360 CAMERA FRAME

END USE PART — Radiant Images prints the entire frame of the AXA 360 camera rig with Markforged.

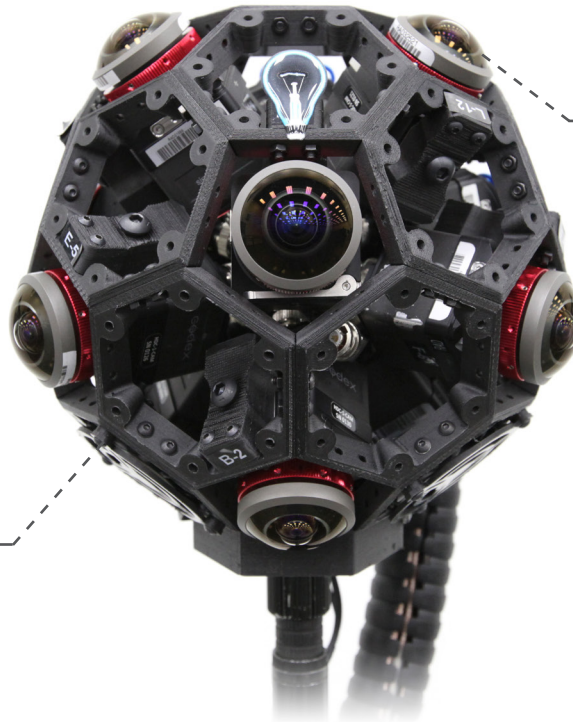
The 3D Printed Parts

PRECISE FITTINGS — The frame consists of high strength polygonal brackets bolted together at an angle.

Radiant Images mounts 12 cameras onto each AXA 360 rig. Each camera is held in place with a Markforged printed bracket.

More than 30 Markforged printed parts comprise each AXA 360 frame. Each frame piece is bolted to at least five other printed parts.

Before using Markforged, Radiant Images outsourced machined 7075 Aluminum frames — a process that was both slow and yielded a heavy rig. By printing the frame in-house out of Onyx and Carbon Fiber on their Markforged Industrial Series printer, Radiant Images builds lighter rigs faster than they could before.

CNC MACHINED	MARKFORGED	SAVINGS
Fabrication Time (per bracket)	48 hrs	11 hrs	77%
Part Weight	137g	51g	63%
